Feasibility Study-Exterior Elevated Elements (E3)

Hoban Property Management

Property Address:
1096 N Mollison Ave
COLONIAL GARDENS APARTMENTS
El Cajon CA 92021

Feasibility Study of Exterior Elevated Elements (E3)

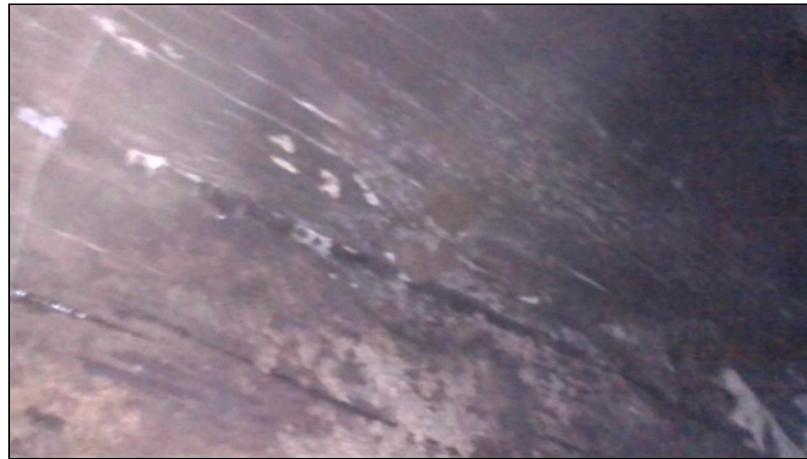
1.0 Wood framing

What appears to be hidden and moisture-damaged wood framing was observed. This condition suggests that the original waterproofing membrane was either never installed or has failed. The apparent damage seems mostly to affect the plywood or decking located beneath the finished walking surface, though we cannot rule out additional compromised components such as joists or blocking. We discovered the damage by drilling small holes at the soffit in areas selected for further evaluation. Once the holes were drilled, we probed the wood using a long screwdriver-like tool and noted that the material felt soft and deteriorated. Additionally, stained and damaged wood was visually confirmed using a borescope (miniature camera analysis).

1.0 Concealed, Moisture damaged wood framing; viewed from borescope camera

We recommend that a larger area of finished surfaces be removed and inspected to verify the full extent of the damage. The source of moisture intrusion should be identified and eliminated. All damaged wood should be repaired or replaced as necessary. Once structural repairs are complete, a proper waterproofing barrier and exterior-rated traffic coating should be installed.

The concrete walking surface at the landing will likely need to be removed to allow for wood repairs beneath, after which a fiberglass-based traffic coating system should be installed in its place.

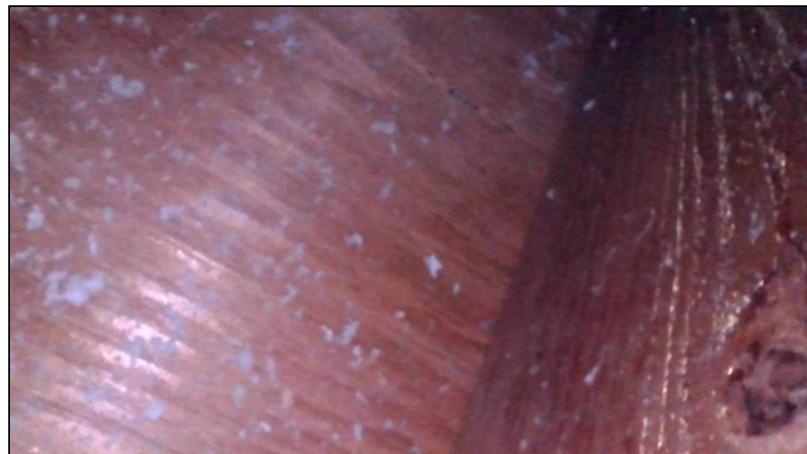
1.0 Concealed, non-moisture damaged wood framing, shown for comparison purposes; viewed from borescope camera. This is what we should see when there's no damage.

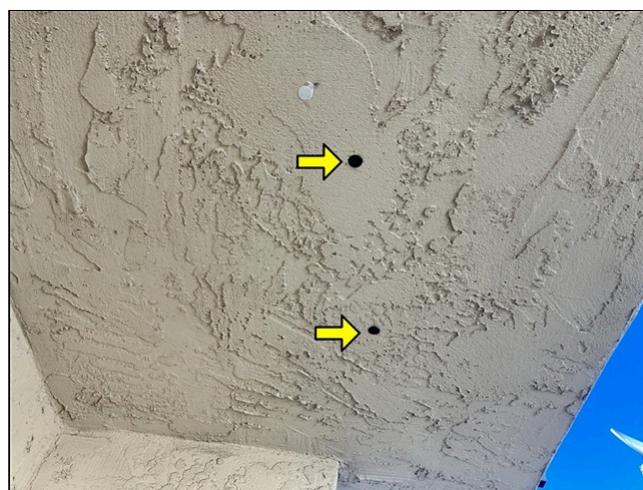
Note: We marked the areas of more severe damage with black PVC plastic caps at the underside to assist contractors in locating the concern. Readers of this report should understand that our borescope inspection method only allows viewing of the bottom surface of the plywood or decking. The top surface is likely in worse condition than what was observed, as it receives more direct exposure to moisture.

1.0 Areas below the hidden/ damaged wood marked out with black PVC plugs

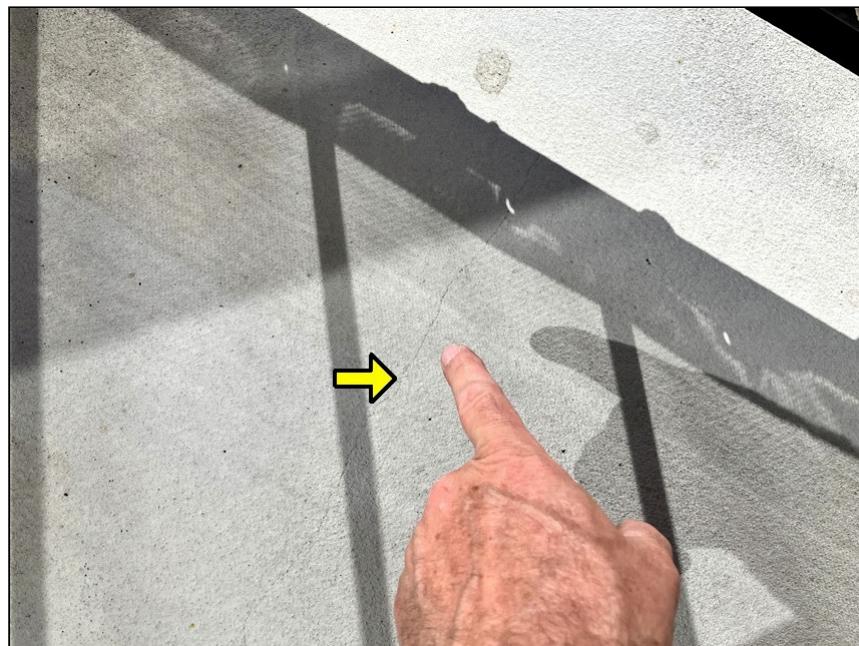
2.0 Walking surfaces & waterproofing

The traffic coating has small cracks that are borderline in severity-under different conditions, they might not warrant immediate repair. However, given the proximity of a wall-mounted air conditioning unit, it's likely that condensate water will regularly drip onto the walking surface. This introduces a consistent moisture source that could exploit even minor coating failures. As a precaution, we recommend sealing these cracks thoroughly to prevent future intrusion and protect the underlying structure.

2.0 Cracks at fiberglass traffic coating
