Inspection of Exterior Elevated Elements (E3)

Hoban Property Management

434 S Mollison Ave
"EL TESORO APARTMENTS"
El Cajon CA 92020

Date: 10/21/2025	Time: 10:00 AM	Report ID: 20251021-434-S-Mollison-Ave
Property: 434 S Mollison Ave "EL TESORO APARTMENTS" El Cajon CA 92020	Customer: Hoban Property Management

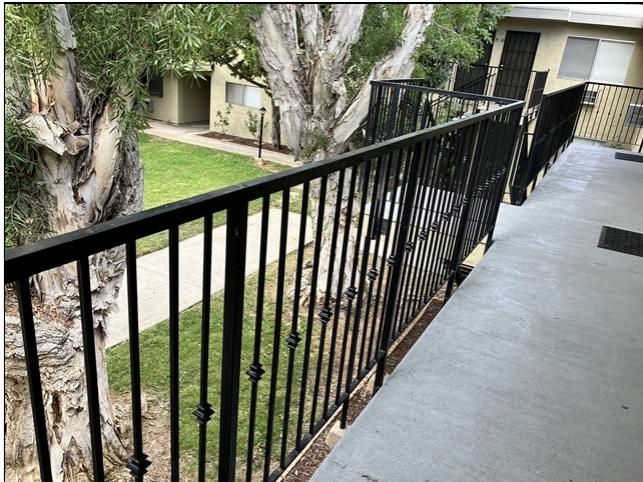
No adverse conditions were observed with the structural or waterproofing components examined.h

The walkways serving units 28 & 29 and 37 thru 39 were inspected and deemed to be in good condition/ no defects

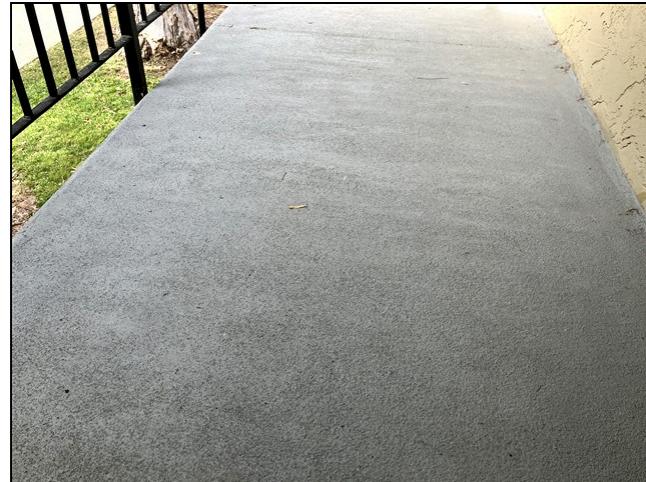
The concrete walking surfaces serving units 28 & 29 and 37 thru 39 were inspected and deemed to be in good condition/ no defects

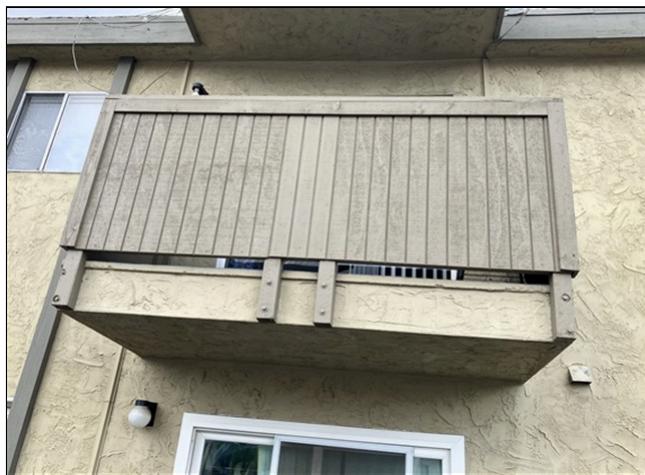
No adverse conditions were observed with the structural, waterproofing, or railing components examined.

The private balconies serving units 20 & 39 were inspected and deemed to be in good condition/ no defects

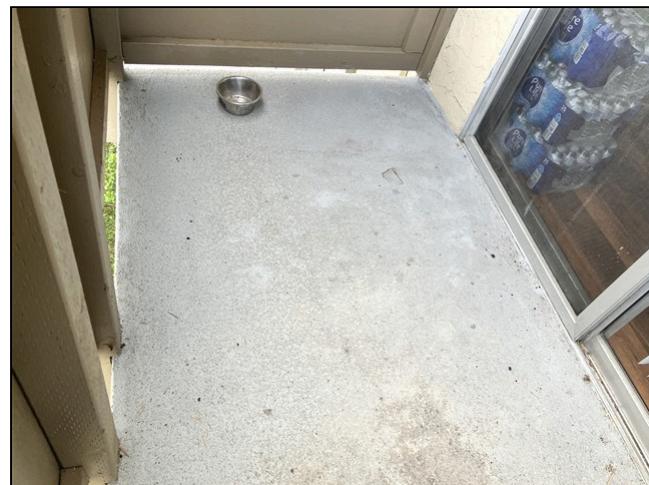
The concrete walking surfaces serving units 20 & 39 were inspected and deemed to be in good condition/ no defects

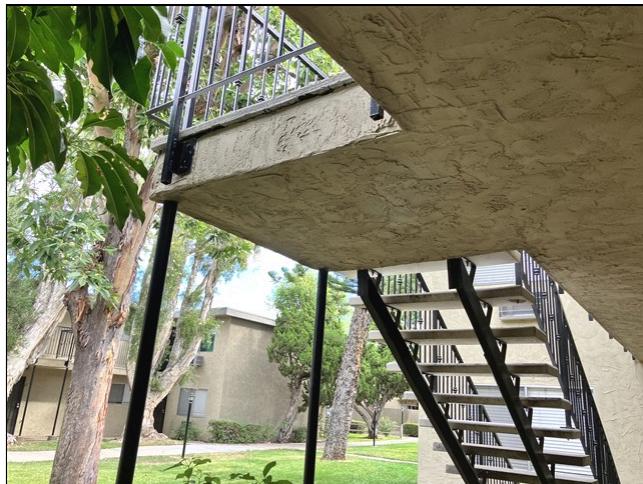
No adverse conditions were observed with the structural or waterproofing components examined.

The landings serving units 20 & 33 were inspected and deemed to be in good condition/ no defects

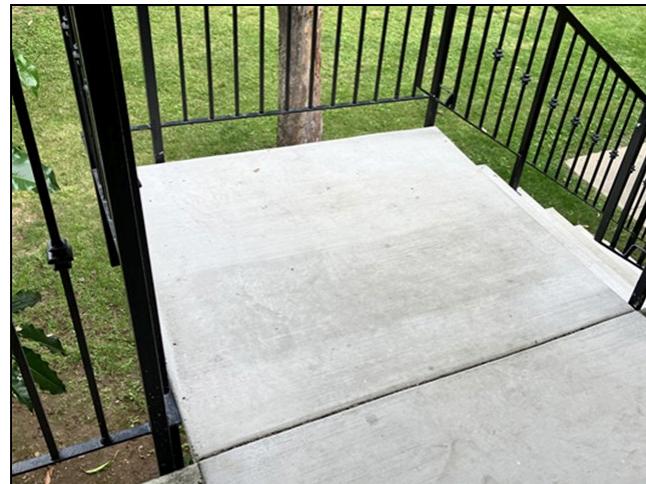
The concrete walking surfaces serving serving units 20 & 33 landings were inspected and deemed to be in good condition/ no defects

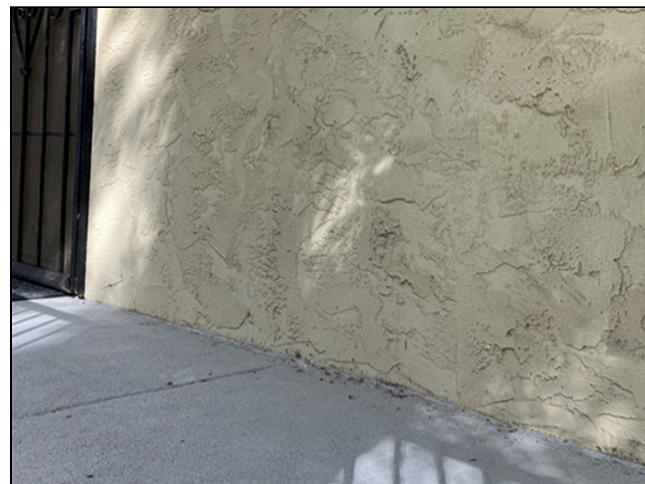
The stucco observed at inspected areas was in normal and acceptable condition. No significant cracking, delamination, or separation was noted during the visual survey. Surface texture and finish appeared consistent with original construction, and no signs of water staining or efflorescence were present at the time of inspection .

Stucco wall cladding was inspected and deemed to be in good condition/ no defects

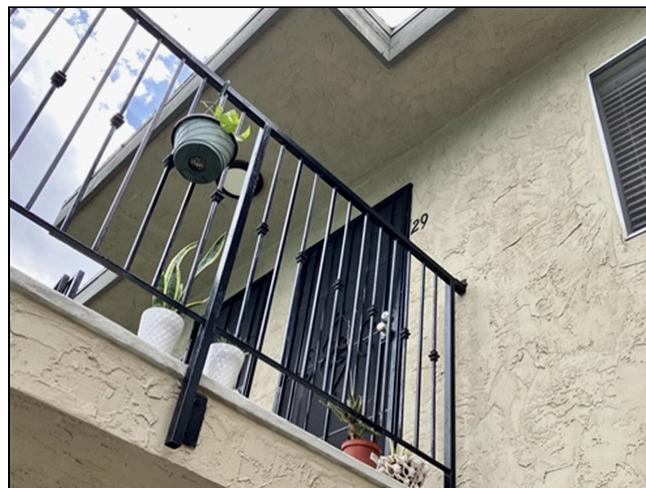
The railings exhibited little to no measurable deflection during testing and appeared to be securely anchored at both post bases and horizontal members. No signs of looseness, weld failure, or excessive movement were observed.

The railings were inspected and deemed to be in functional condition/ no defects

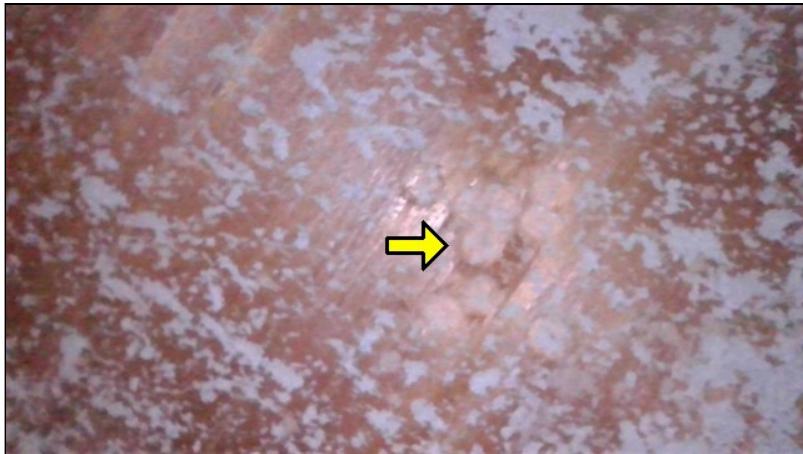
9.5 Normal-looking marks created during impact testing were observed through the borescope camera. These marks appeared as shallow indentations and surface scuffs consistent with controlled probing of the decking and joists. The impressions were uniform in character and did not exhibit signs of excessive force, splintering, or material degradation. Their appearance aligns with expected results from standard impact testing procedures and did not raise concern for structural compromise or abnormal response. No discoloration, fungal growth, or irregular surface texture was noted in the surrounding wood.

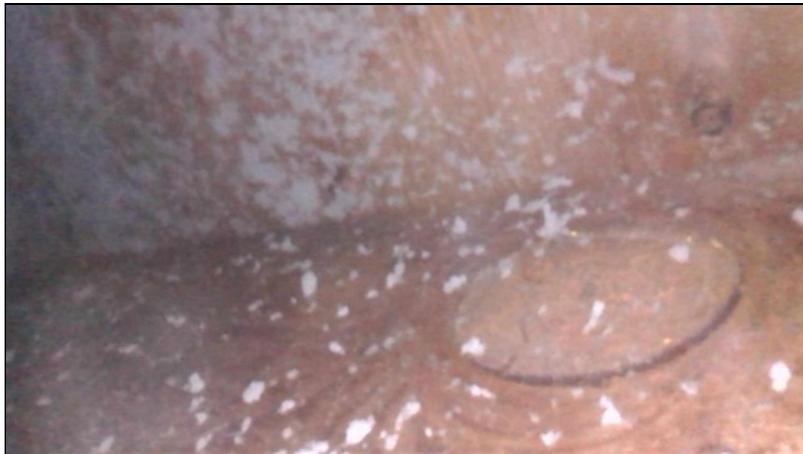
9.6 Normal-looking wood (with typical construction overspray) was observed through the borescope camera during inspection of concealed framing areas. The surfaces appeared intact, with no visible signs of major staining, rot, delamination, or insect activity. Grain patterns and coloration were consistent with original construction materials, and no structural irregularities or distress indicators were present. The wood condition was considered sound and free of defects at the time of inspection.
