Inspection of Exterior Elevated Elements (E3)

Hoban Property Management

434 S Mollison Ave
"EL TESORO APARTMENTS"
El Cajon CA 92020

Date: 10/21/2025	Time: 10:00 AM	Report ID: 20251021-434-S-Mollison-Ave
Property: 434 S Mollison Ave "EL TESORO APARTMENTS" El Cajon CA 92020	Customer: Hoban Property Management

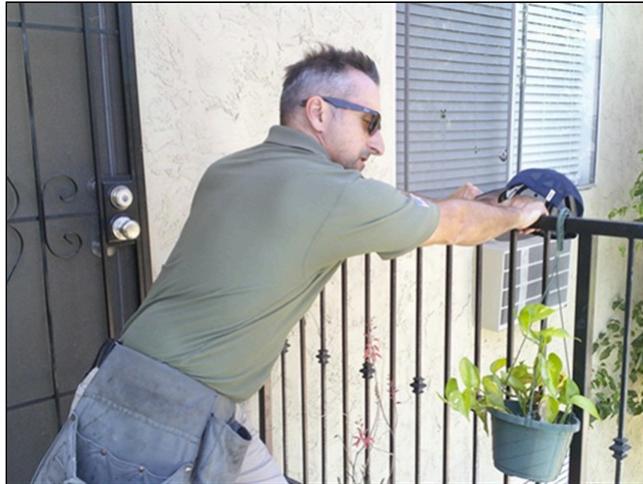
The railings exhibited little to no measurable deflection during testing and appeared to be securely anchored at both post bases and horizontal members. No signs of looseness, weld failure, or excessive movement were observed.

9.0 Inspector testing the performance of the railings

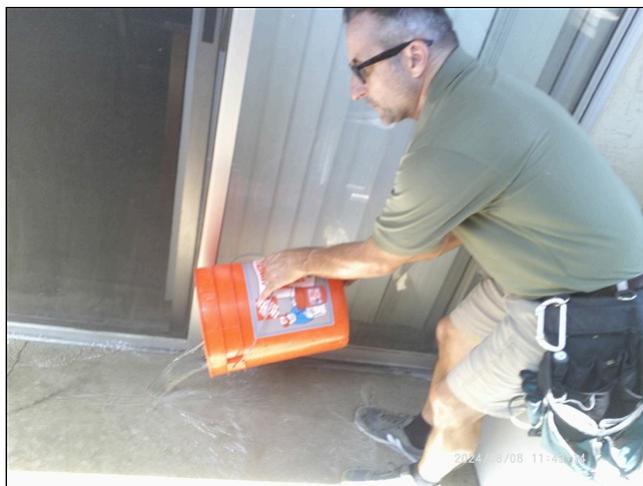
We placed water on the inspected element to observe the performance of the drainage and waterproofing. Unless noted otherwise the drainage and waterproofing were deemed functional.

9.1 Inspector placing water on the walking surface to observe waterproofing and drainage performance.

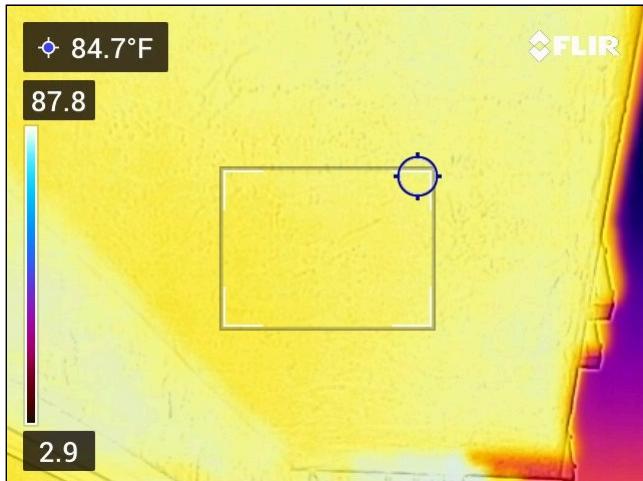
Unless noted otherwise in the individual element descriptions, no anomalous thermal patterns were observed. Surface temperatures appeared consistent with expected ambient conditions, and no signs of active moisture intrusion or thermal bridging were detected at the time of inspection.

9.2 Inspector using infrared camera (IR) to scan for anomalies.

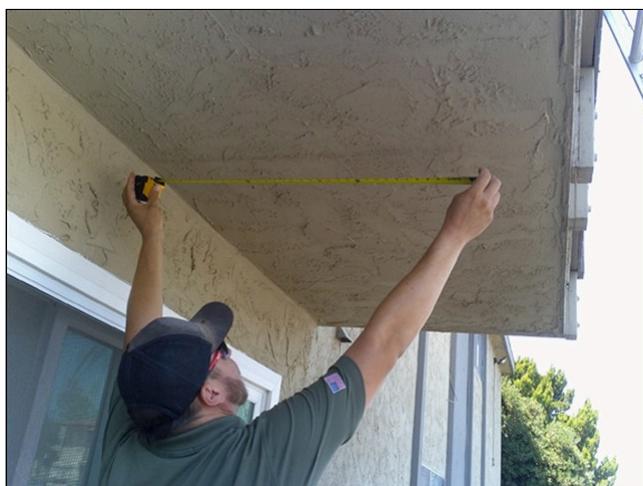
9.3 Measuring for proper location of holes to be drilled

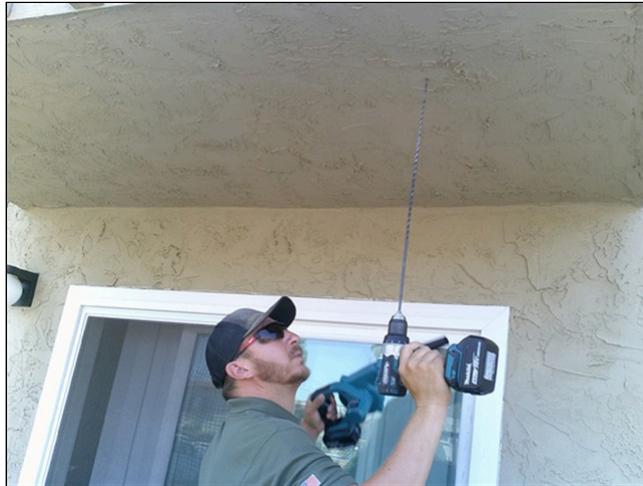
9.4 Holes being drilled to allow for impact and borescope testing

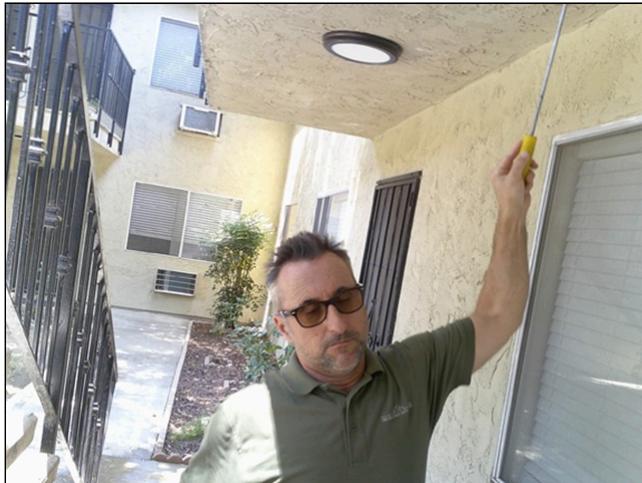
At this stage, we also measured the depth of the joists using a calibrated probe and visual reference against known material dimensions. Joist depth was confirmed to be nominal 2x8 lumber, consistent with standard cantilever framing practices for elevated walkways in multi-family construction. No abnormal deflection, hollow response, or structural irregularities were noted during testing.

9.5 Inspector performed impact testing on the wood-framed components to assess material integrity and detect signs of deterioration. This involved applying controlled force to exposed joists and decking using a blunt instrument, allowing for evaluation of surface response, fastener stability, and potential internal decay. The procedure helps identify dry rot, delamination, or compromised connections without invasive removal.

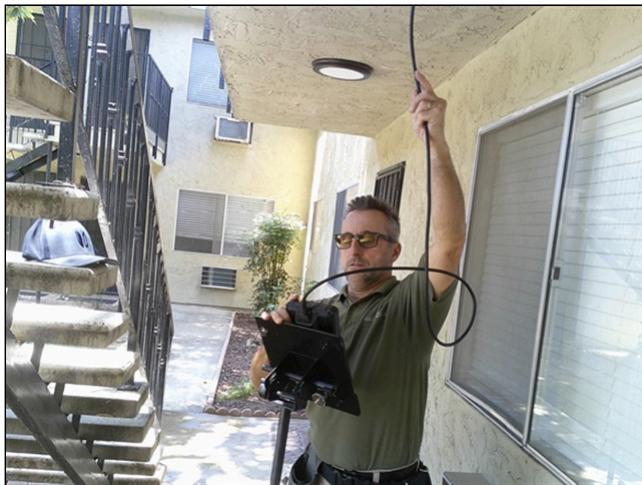
In this case, the wood framing observed through the borescope appeared normal and consistent with original construction, which often includes incidental spider webs, overspray, and other minor debris typical of enclosed framing cavities. No visible staining, rot, delamination, or irregular modifications were noted. Fasteners and framing connectors appeared intact, and the wood surfaces showed no signs of active deterioration or distress.

9.6 Inspector used a borescope camera to view concealed framing and waterproofing membranes within soffit cavities and transition areas. This tool allows internal visual access without destructive removal, enabling inspection of joists, decking, and moisture barriers. Focus was placed on identifying staining, deterioration, or membrane failure. Observed conditions appeared consistent with original construction. No signs of distress, staining, or abnormal modifications were noted.

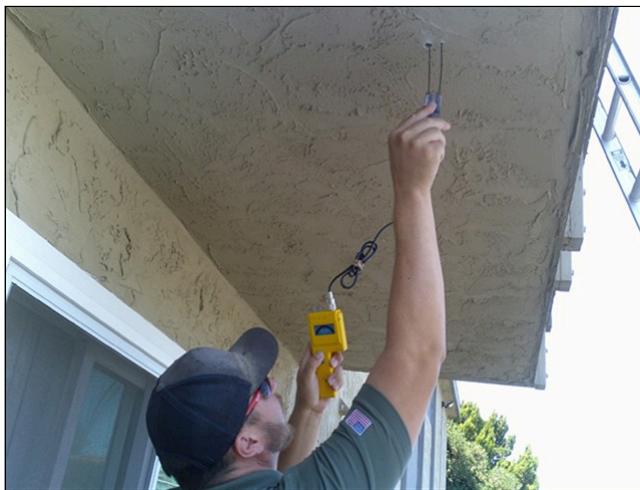
We used a Delmhorst J-lite moisture meter with long accessory probe to test the moisture content of the plywood deck and/ or joists. We obtained readings of 9%-11%, which is generally considered to be in the normal range. This test should be repeated on future inspections to compare moisture content of the wood framing.

9.7 Inspector using meter to measure the moisture content of concealed wood framing components

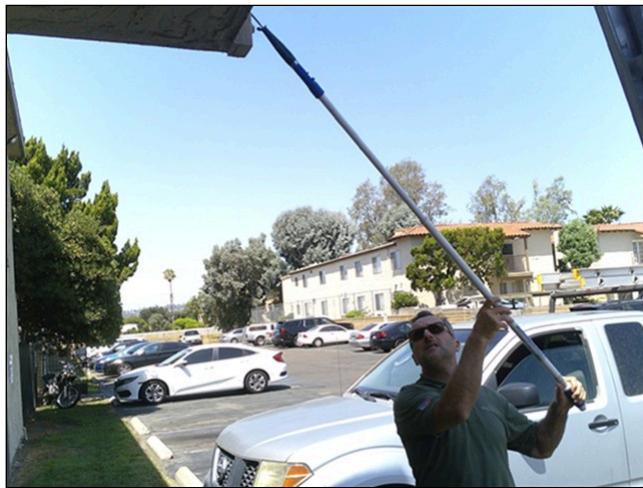
various areas. This is done to test for moisture and/ or termite damaged wood. Unless noted otherwise, no damage or anomalous conditions were observed.

9.8 Inspector probing exposed wooden components for defects

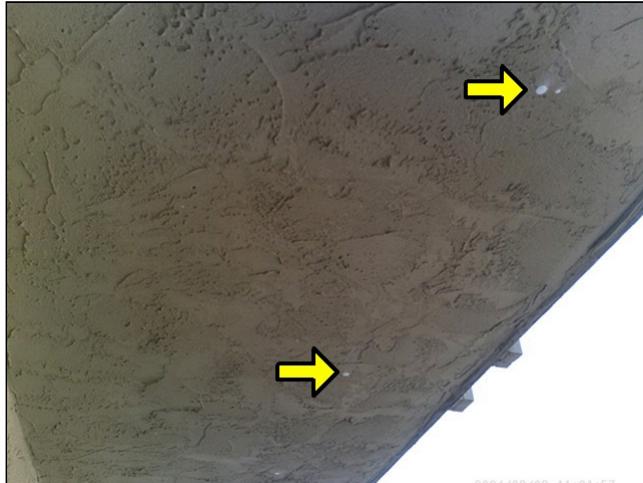
9.9 Tight fitting plugs were installed to repair all locations where holes were drilled.

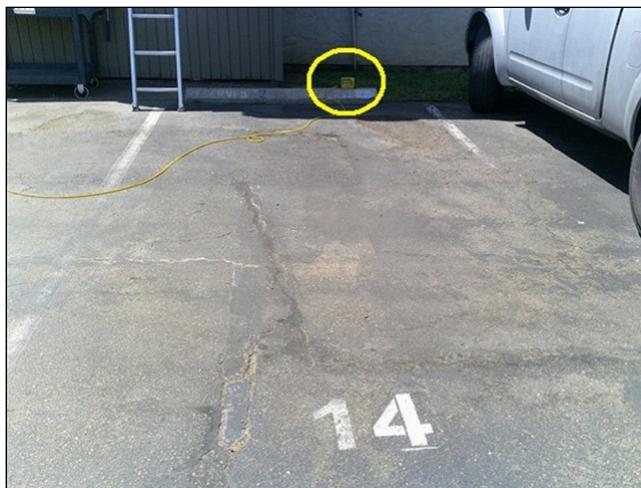
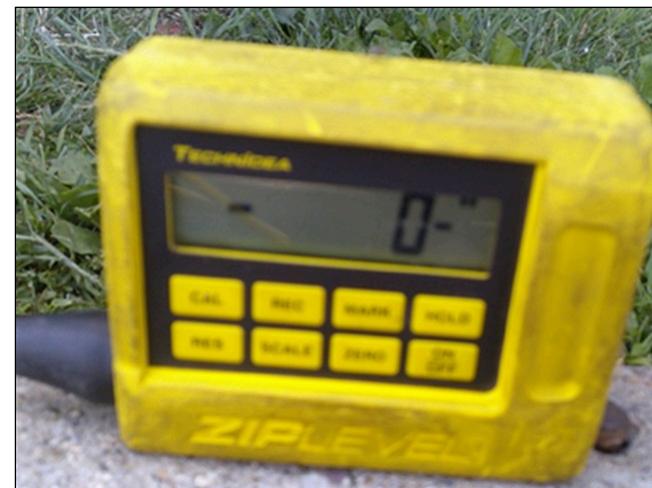
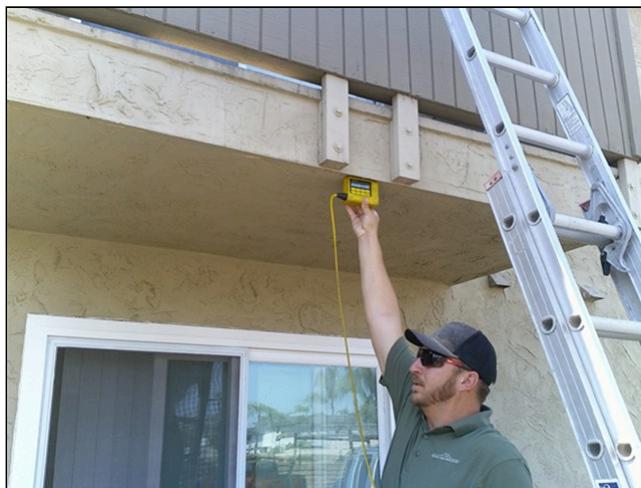
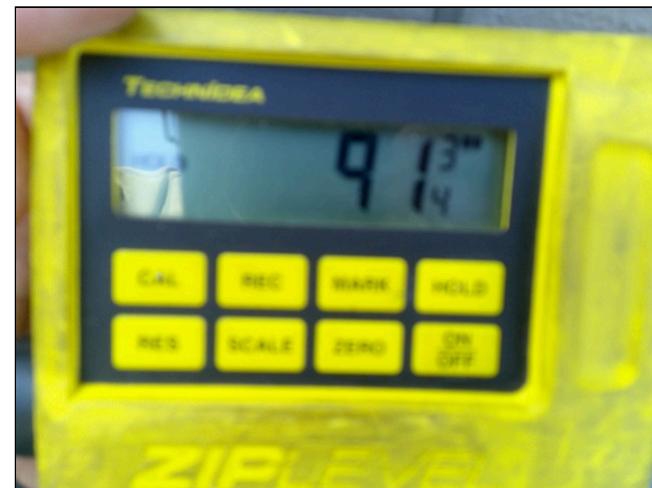
(1) We measured between a reference point and the center/ underside of the soffit serving unit 20 balcony. The reference point we used was on top of the curb that protects the building from vehicle impacts (at spot 14). The curb was chosen as our reference point because we believe it's unlikely to move over time. We obtained a measurement of 91-3/4".

10.0 Location of the reference point used for our vertical measurement.

10.0 High precision altimeter set to zero at our reference point.

10.0 "Measured to" location we selected.

10.0 Precise vertical measurement between the "reference point" and "measured to" location.

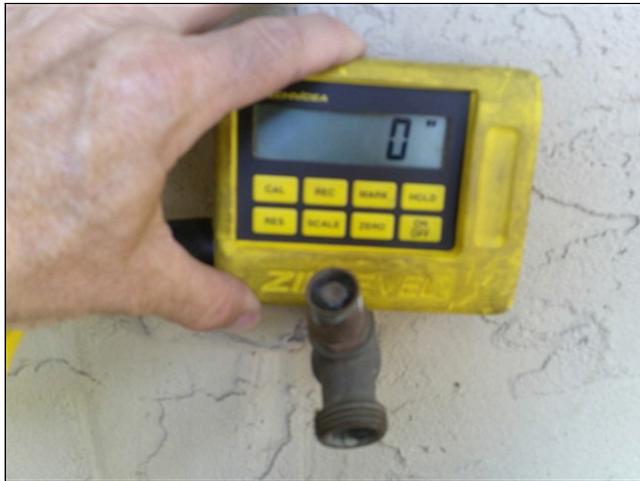
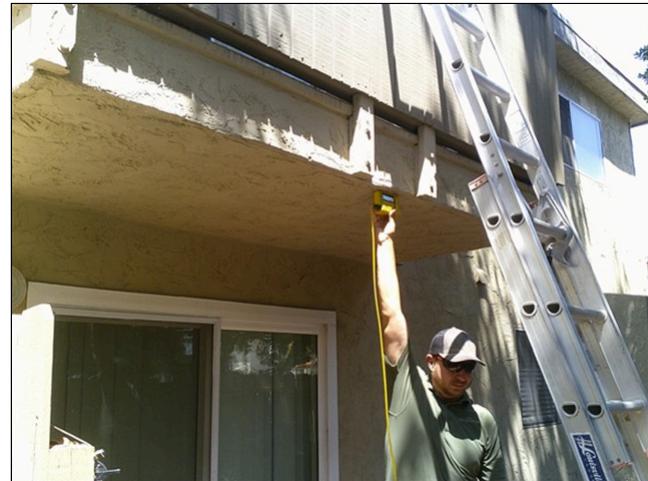
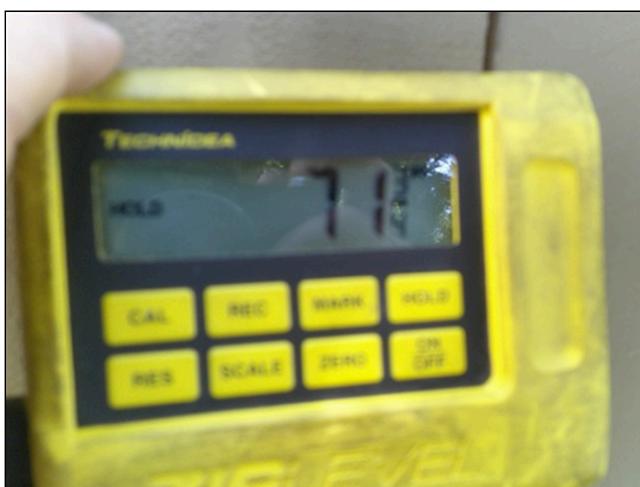
We measured between a reference point and the center/ underside of the soffit serving unit 39 balcony. The reference point we used was the top of the nearby hose spigot. The hose spigot was chosen as our reference point because we believe it's unlikely to move over time. We obtained a measurement of 71-3/4".

10.0 Location of the reference point used for our vertical measurement.

10.0 "Measured to" location we selected.

10.0 Precise vertical measurement between the "reference point" and "measured to" location.
